United States Coast Guard, First District
Lighthouse Protection Studies, New England

Sankaty Head Light Station Nantucket, Massachusetts

US Army Corps
of Engineers
New England Division

SANKATY HEAD LIGHT STATION, NANTUCKET, MA
EROSION STUDY

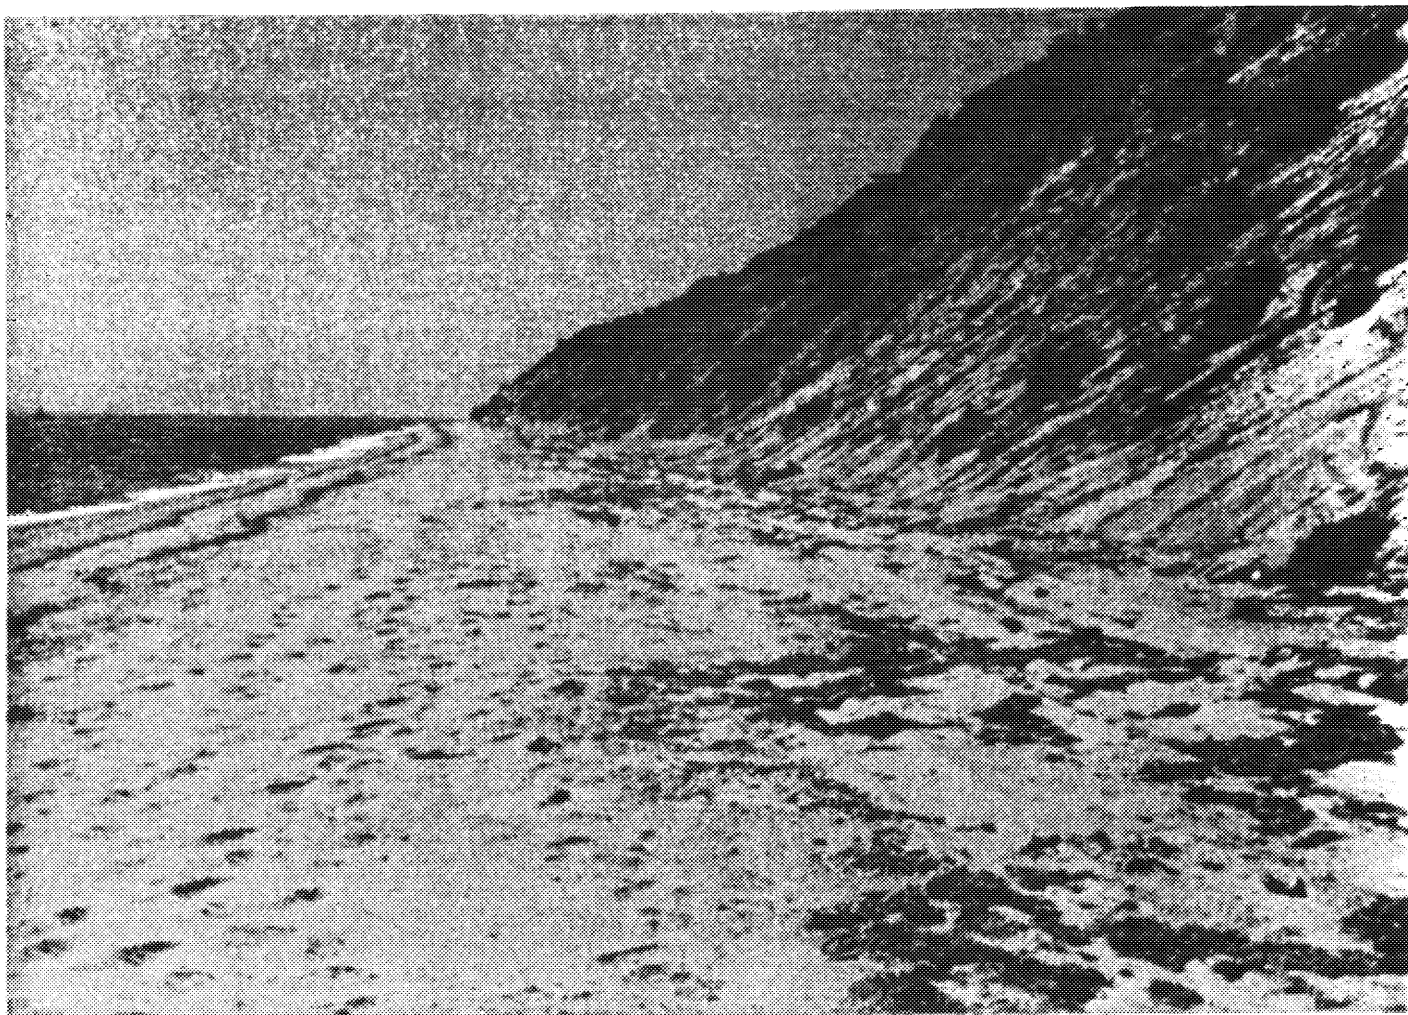
PHOTO 1 - BEACH AND BLUFF SLOPE
AT SANKATY, JUNE, 1989
(NORTH OF LIGHTHOUSE, LOOKING SOUTH)

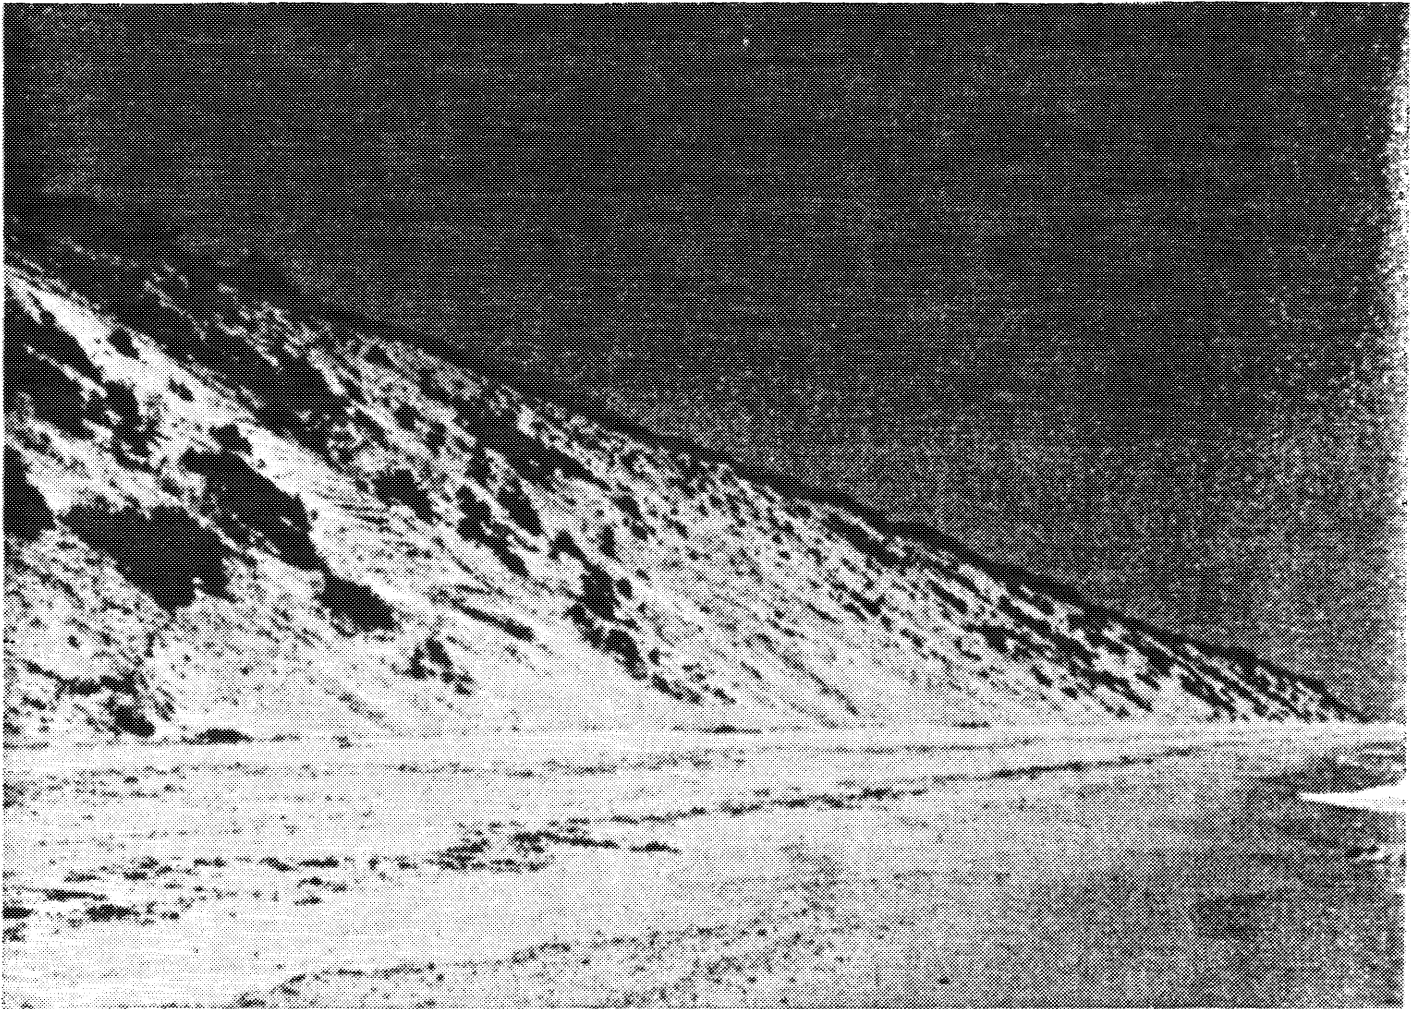
PHOTO 2 - BEACH AND FACE OF BLUFF IN FRONT OF LIGHTHOUSE, JUNE 1989
(LOOKING NORTH)

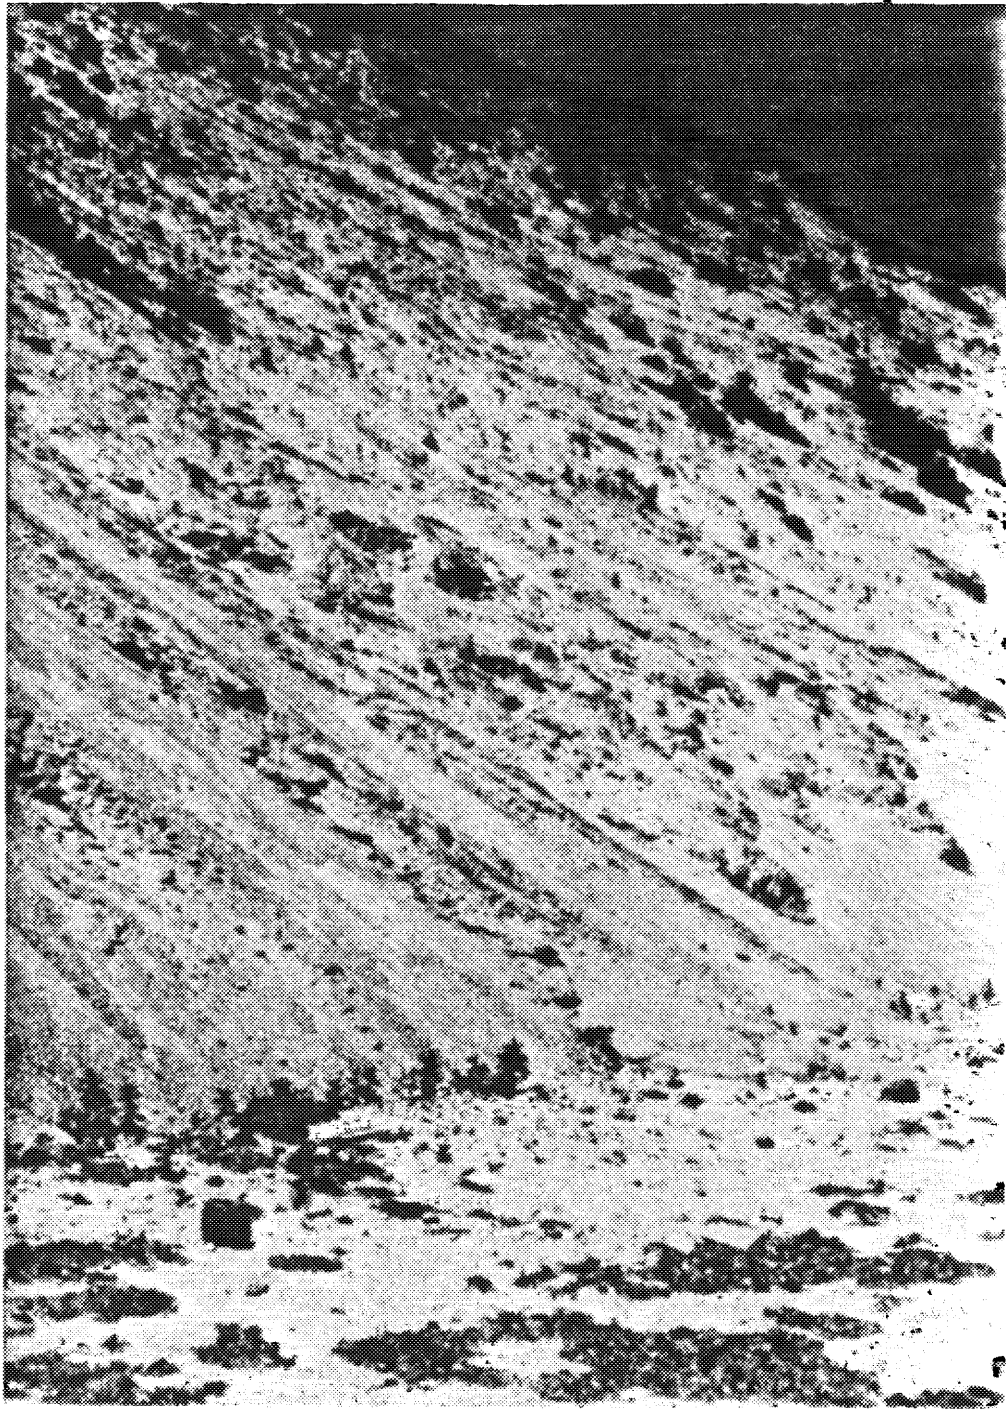
PHOTO 3 - BLUFF FACE IN FRONT OF LIGHTHOUSE, JUNE 1989

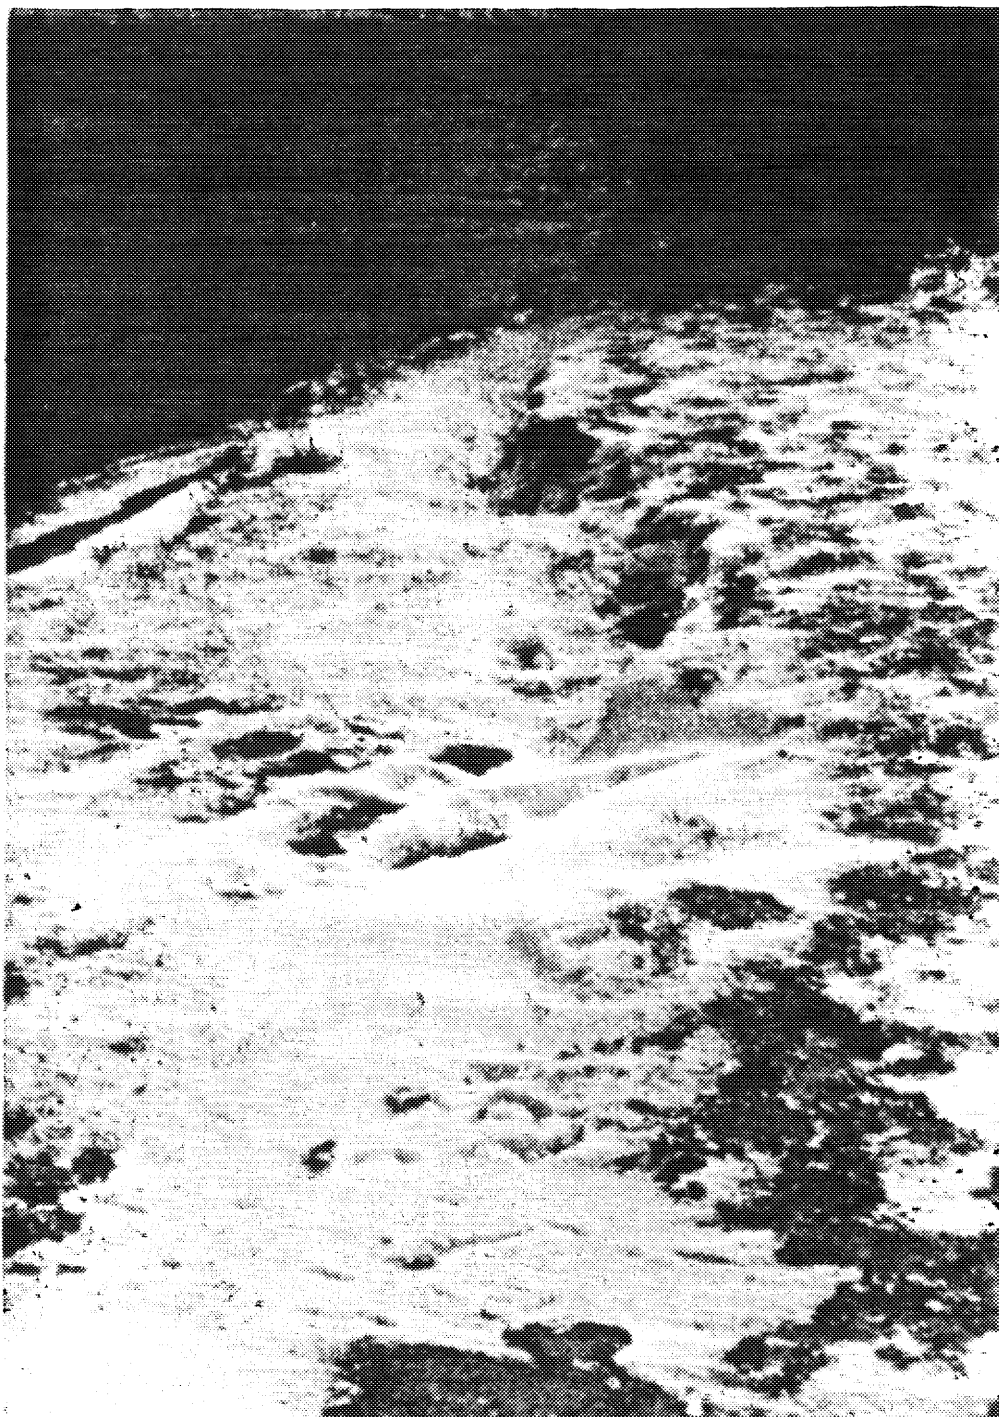
PHOTO 4 - SLOUGHING OF UPPER BLUFF MATERIAL, FEBRUARY 1989

Sankaty bluff is entirely wave cut in origin. Waves undercut the bluff especially in storm conditions. The resultant over steepening causes slumping and bluff failure by mass wasting. Because of the abundant clay in the sediments composing the bluffs, the slumping and failure is periodic and incremental and occasionally catastrophic in nature.

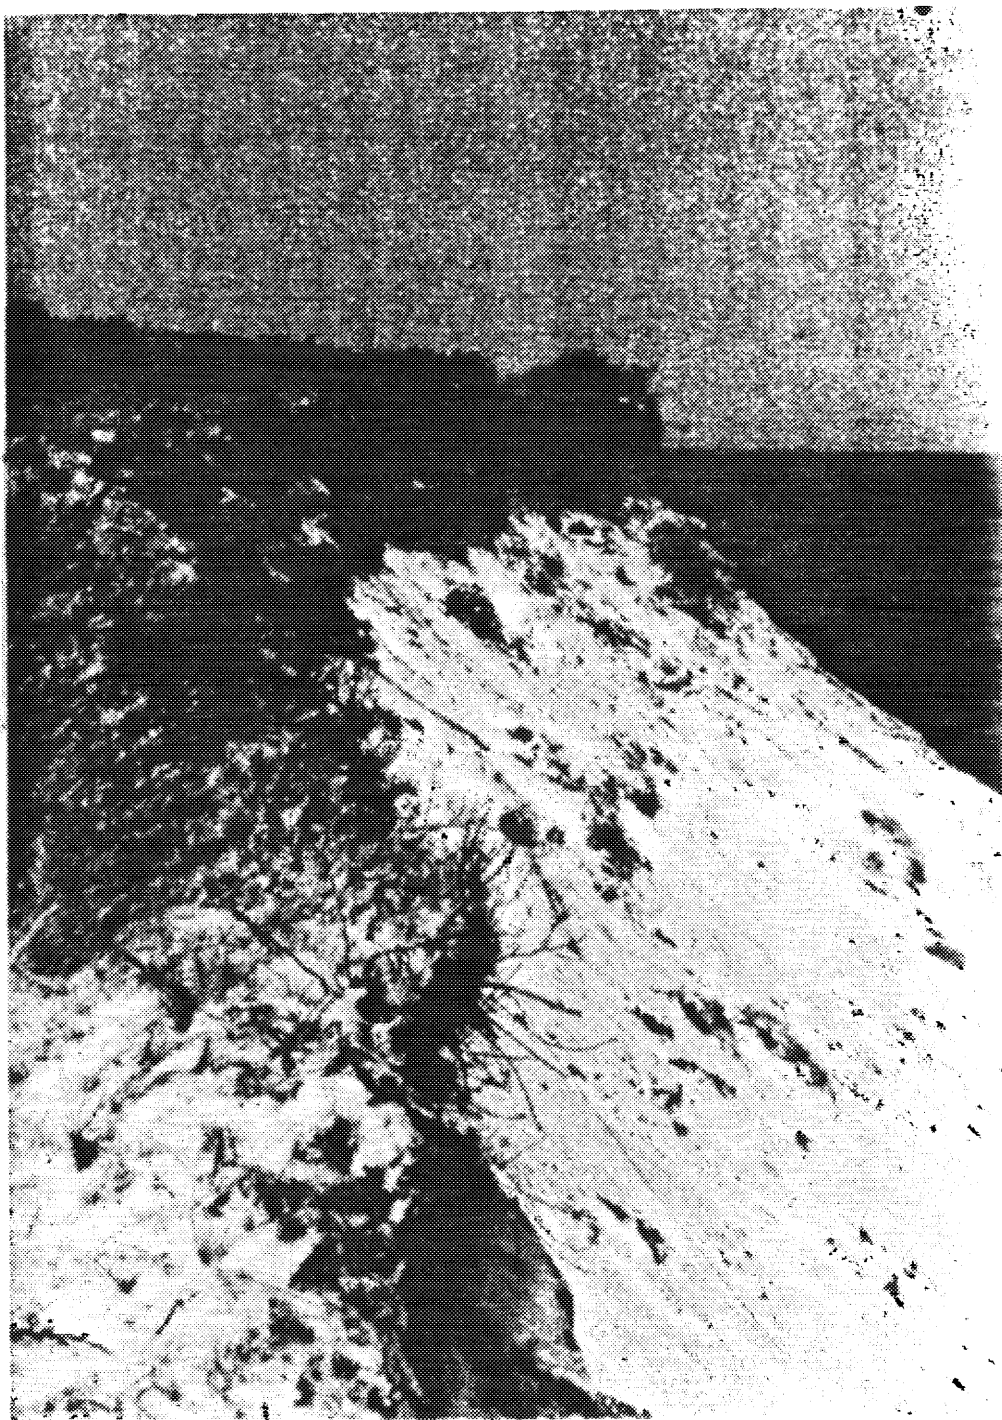
PHOTO 5 - TOP OF BLUFF, FEBRUARY 1989

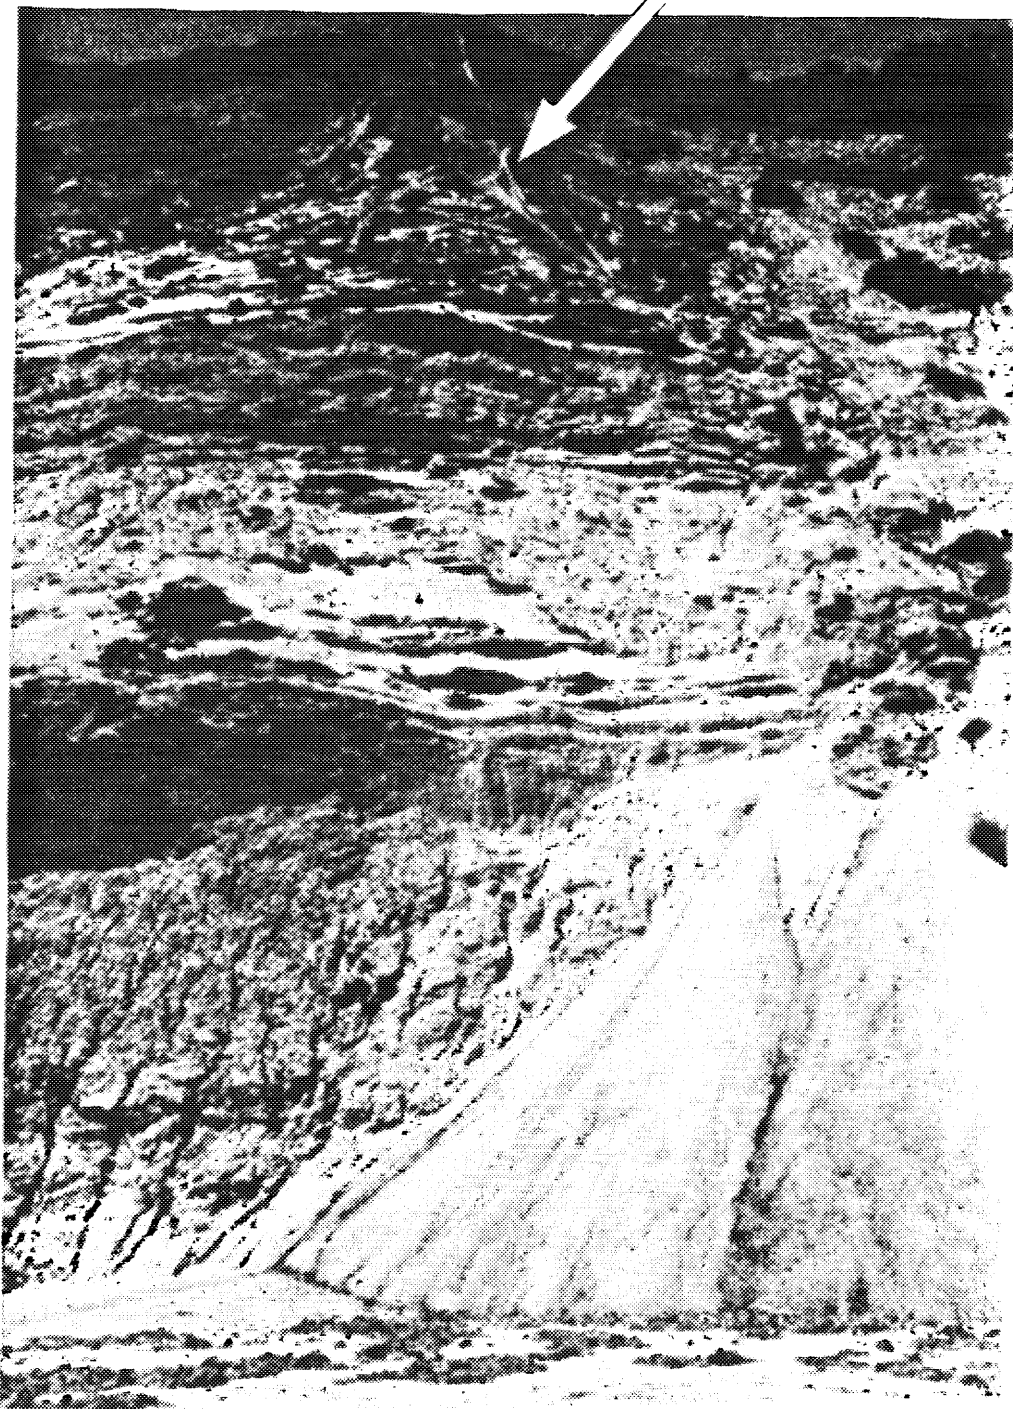
Recently, homeowners have taken steps to alleviate possible destruction of their houses from the continued erosion of the bluffs. Two houses south of the lighthouse property have been moved back approximately 100 feet. One recent attempt to stabilize the slope appears to have failed. A nylon mesh netting had been placed over the face of the slope and then staked in place. It does not seem to have had any significant effect on the continued erosion and retreat of the bluffs. (See Photo 6.)

PHOTO 6 - FAILED EROSION CONTROL METHOD (NYLON MESH), JUNE 1989
(SOUTH OF LIGHTHOUSE PROPERTY)
(NOTE NYLON MESH ON UPPER PORTION OF BLUFF)

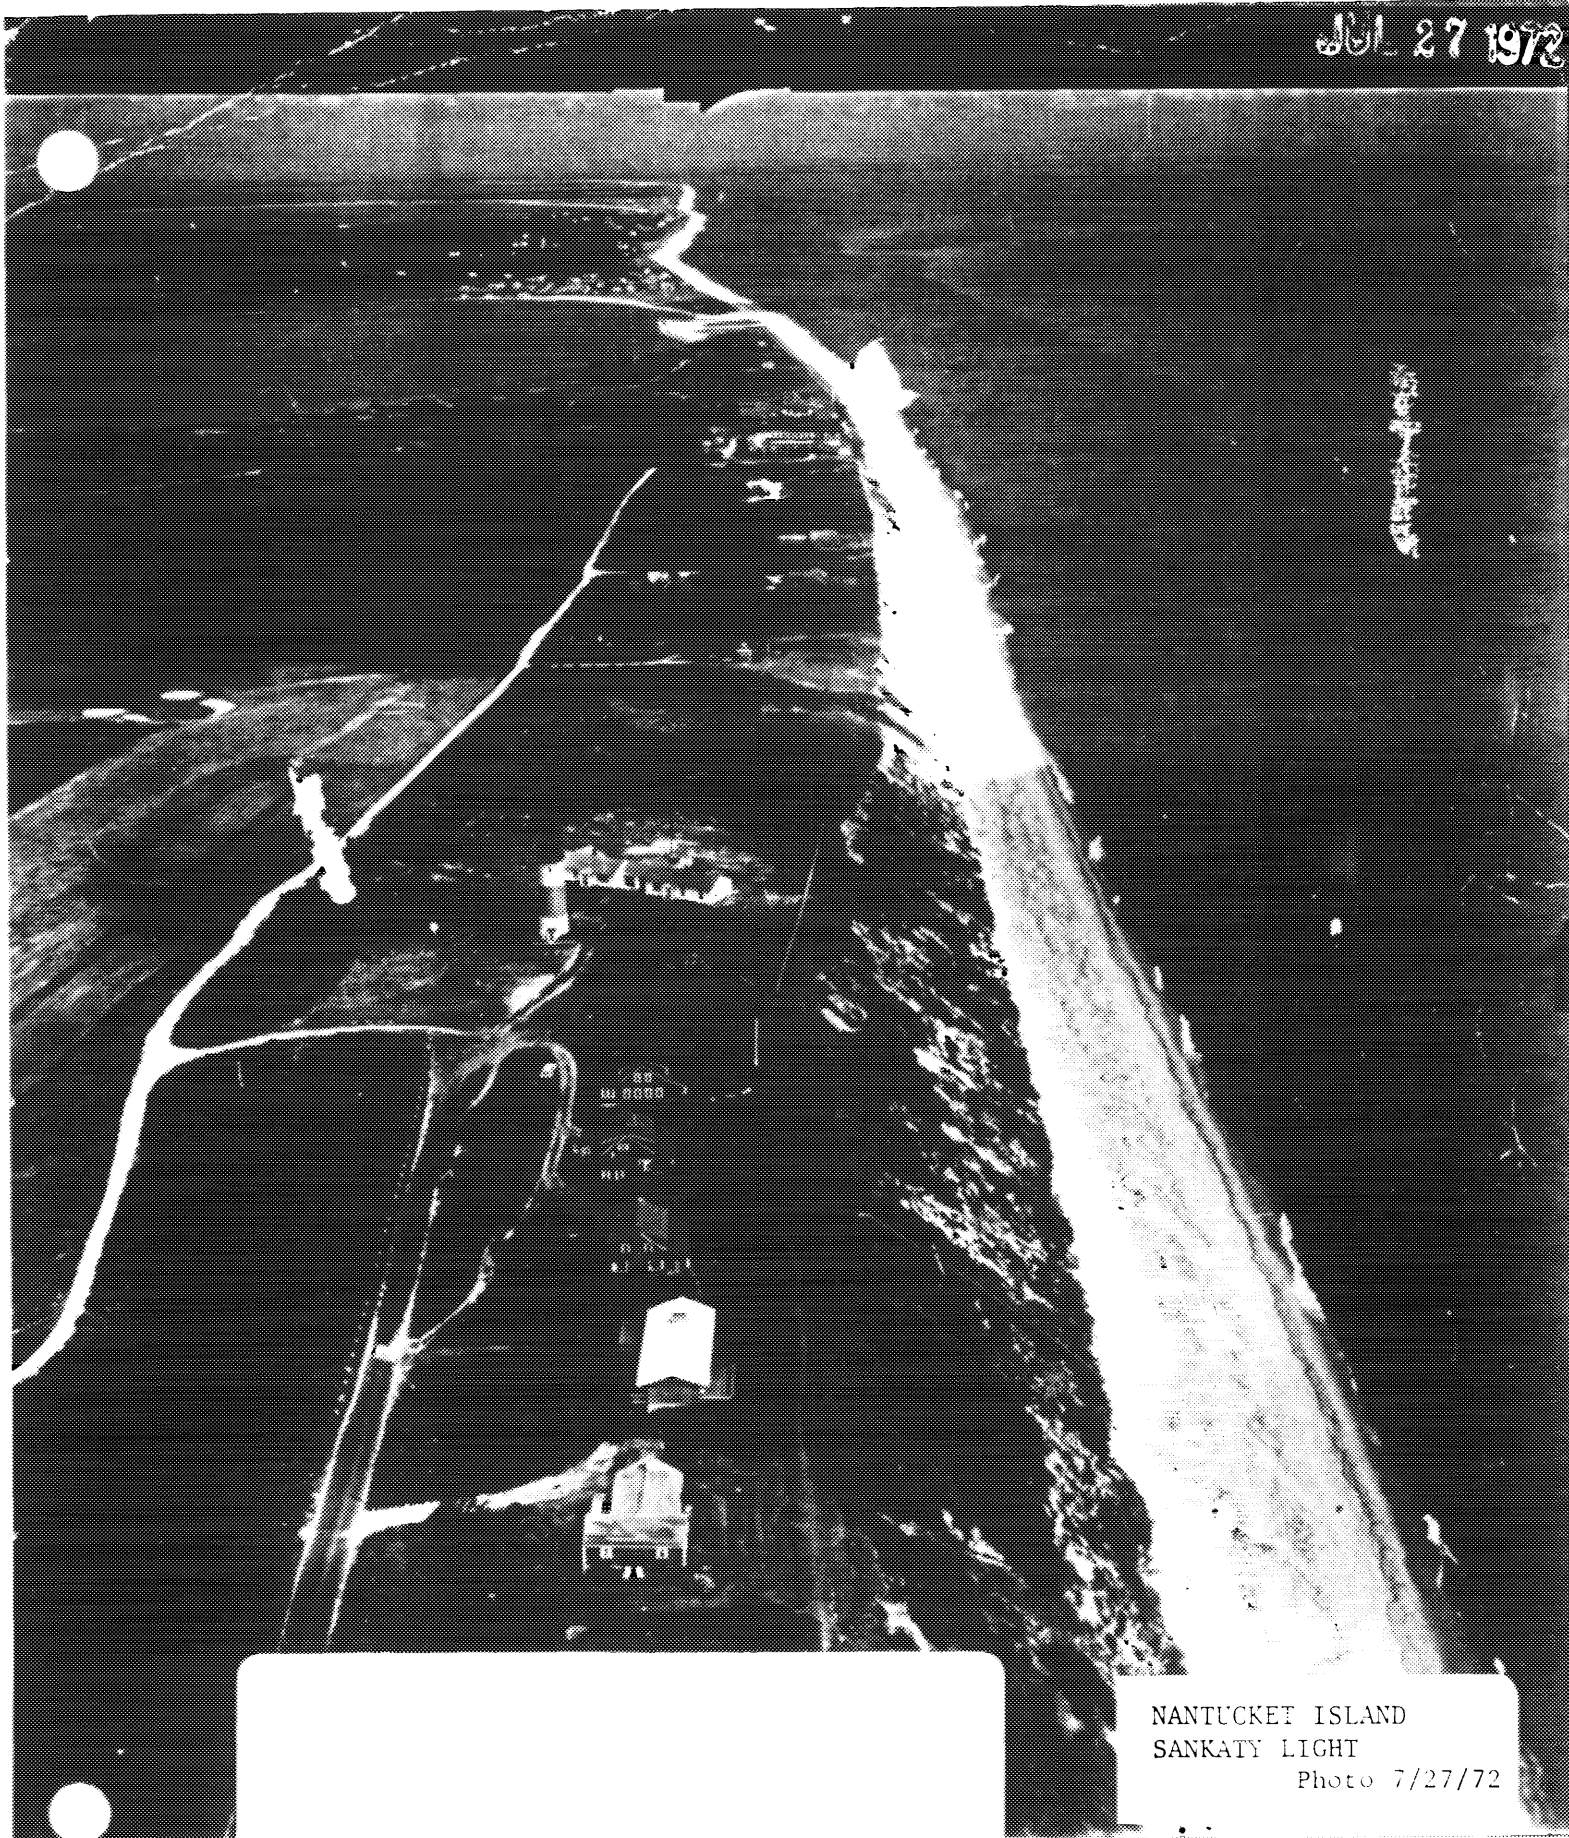
By comparing aerial photographs from 1972 and 1989 (See Photos 7 & 8) you can see a definite change in the vegetative cover of the slope. By 1977, vegetation on the bluff face was sparse, according to a report by Dr. Wesley N. Tiffney, Jr. (See Appendix 3 - Miscellaneous Reports). Recent observations noted that vegetation on the face of the bluff is believed to have slumped down from the top and not to have necessarily taken root on the slope face.

PHOTO 7 - SANKATY LIGHTHOUSE, JULY 1972

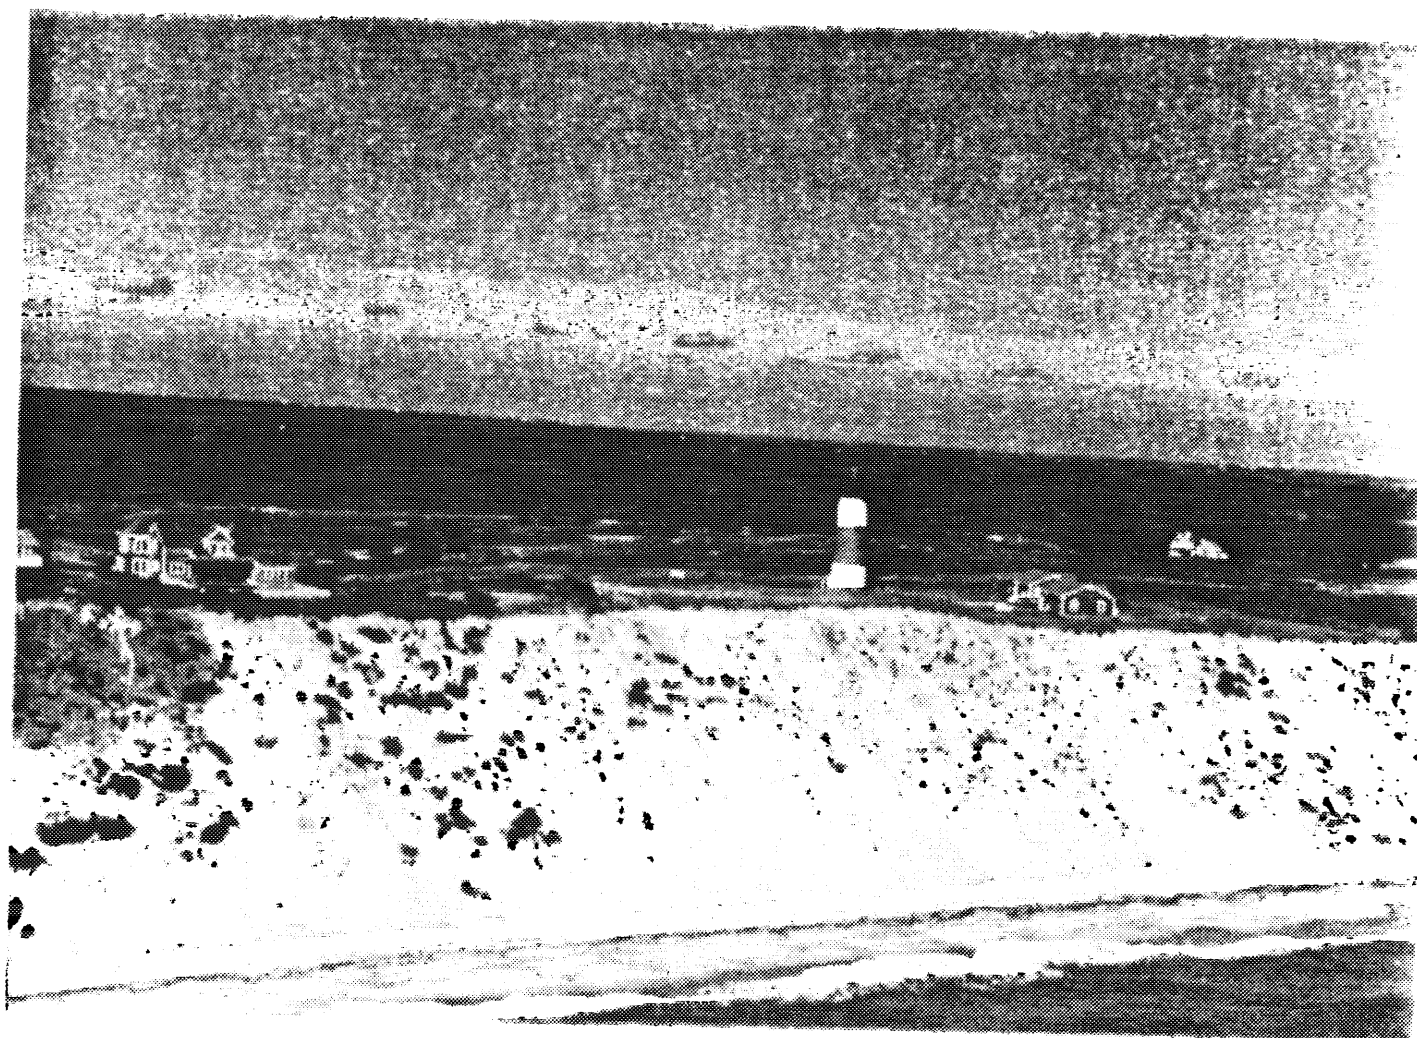
PHOTO 8 - SANKATY LIGHTHOUSE, AUGUST 1988

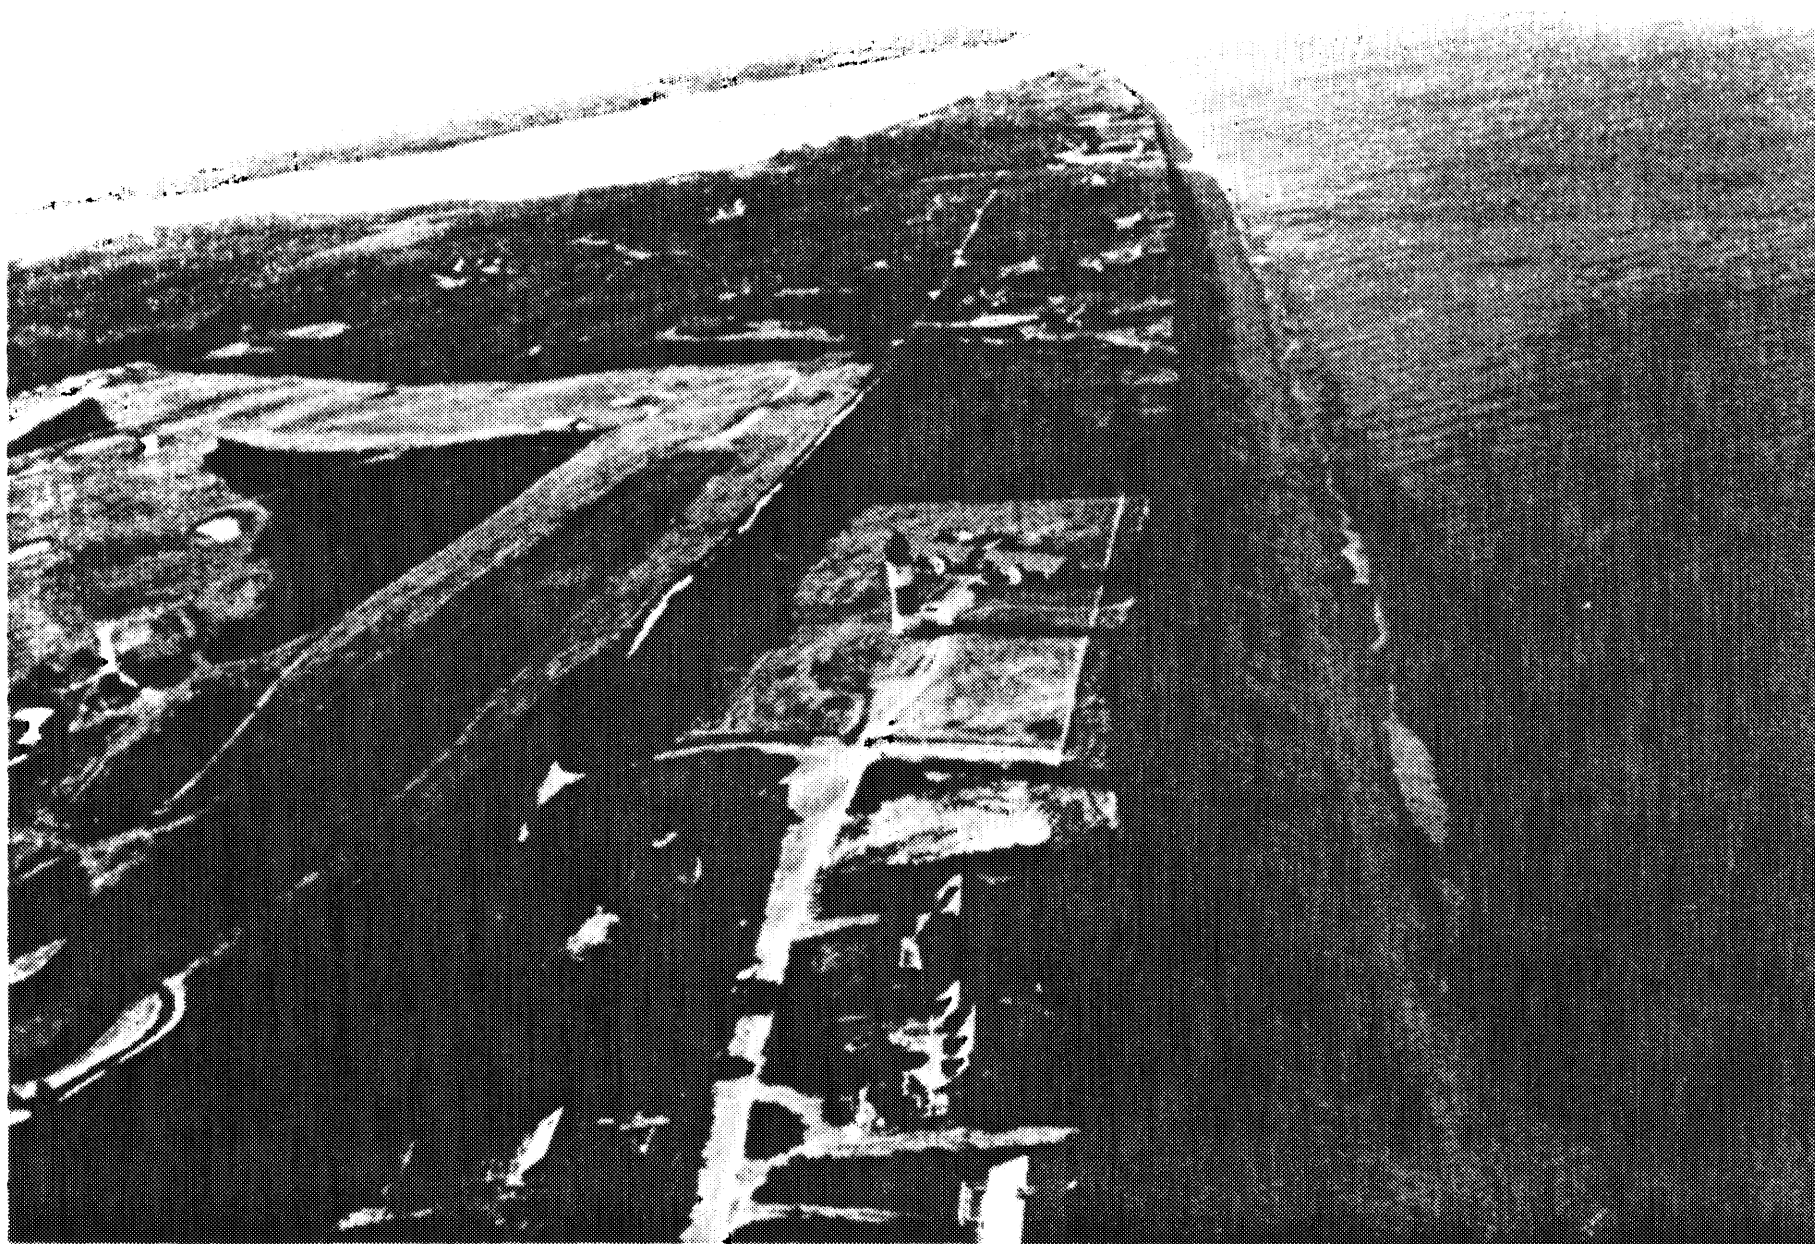
PHOTO 9 - SANKATY LIGHTHOUSE, 1985

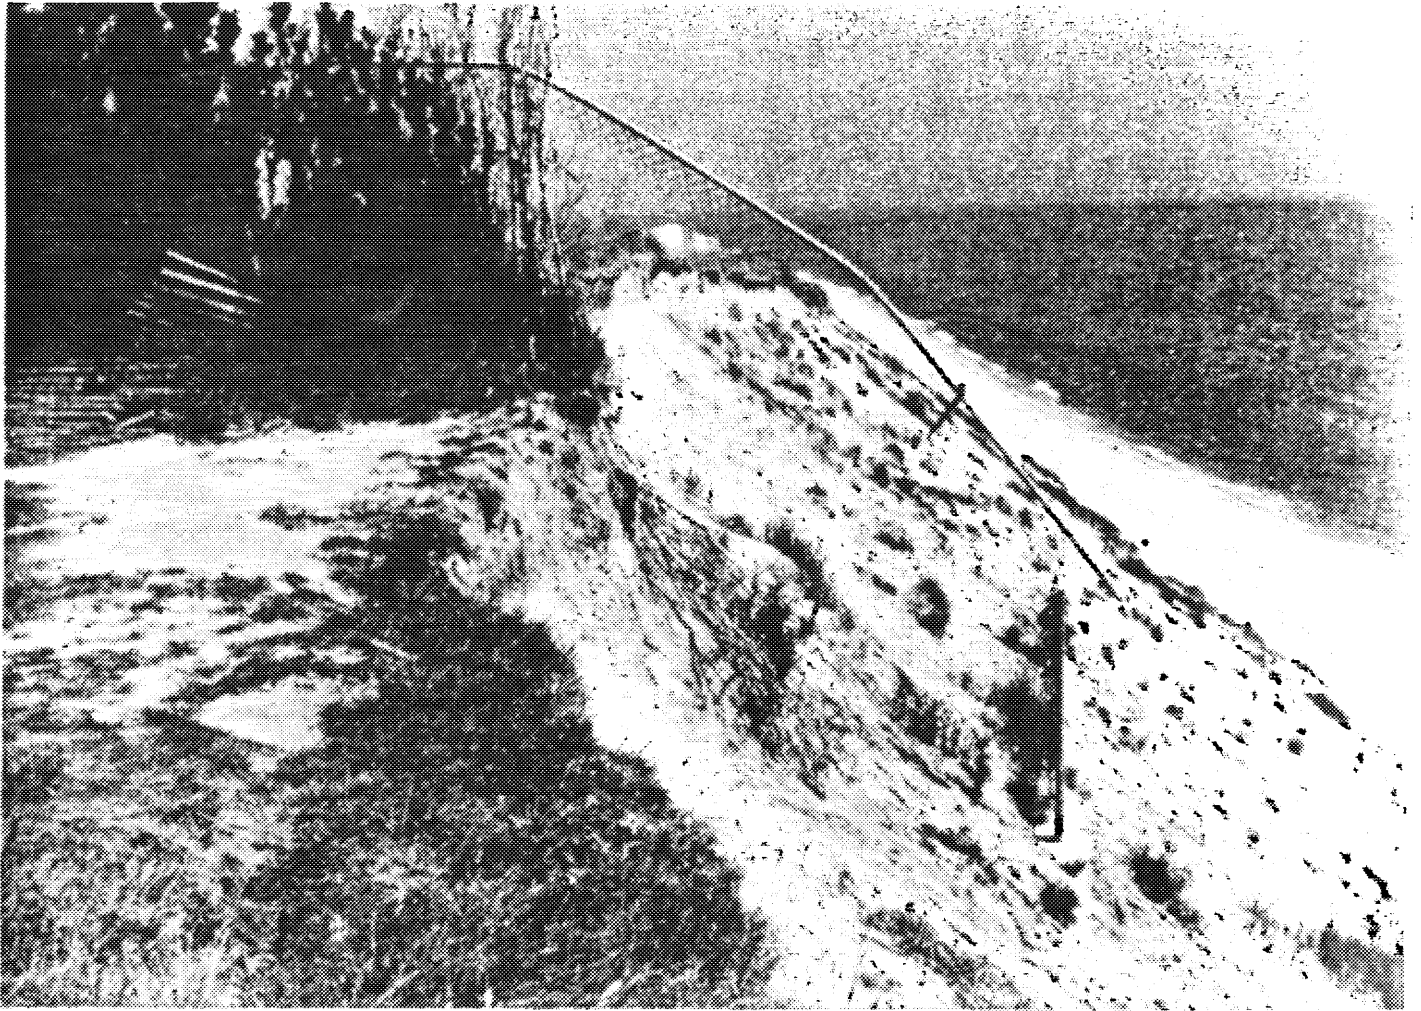
PHOTO 10 - FENCE AT SOUTH PROPERTY BOUNDARY, JUNE 1989
(LOOKING NORTH)

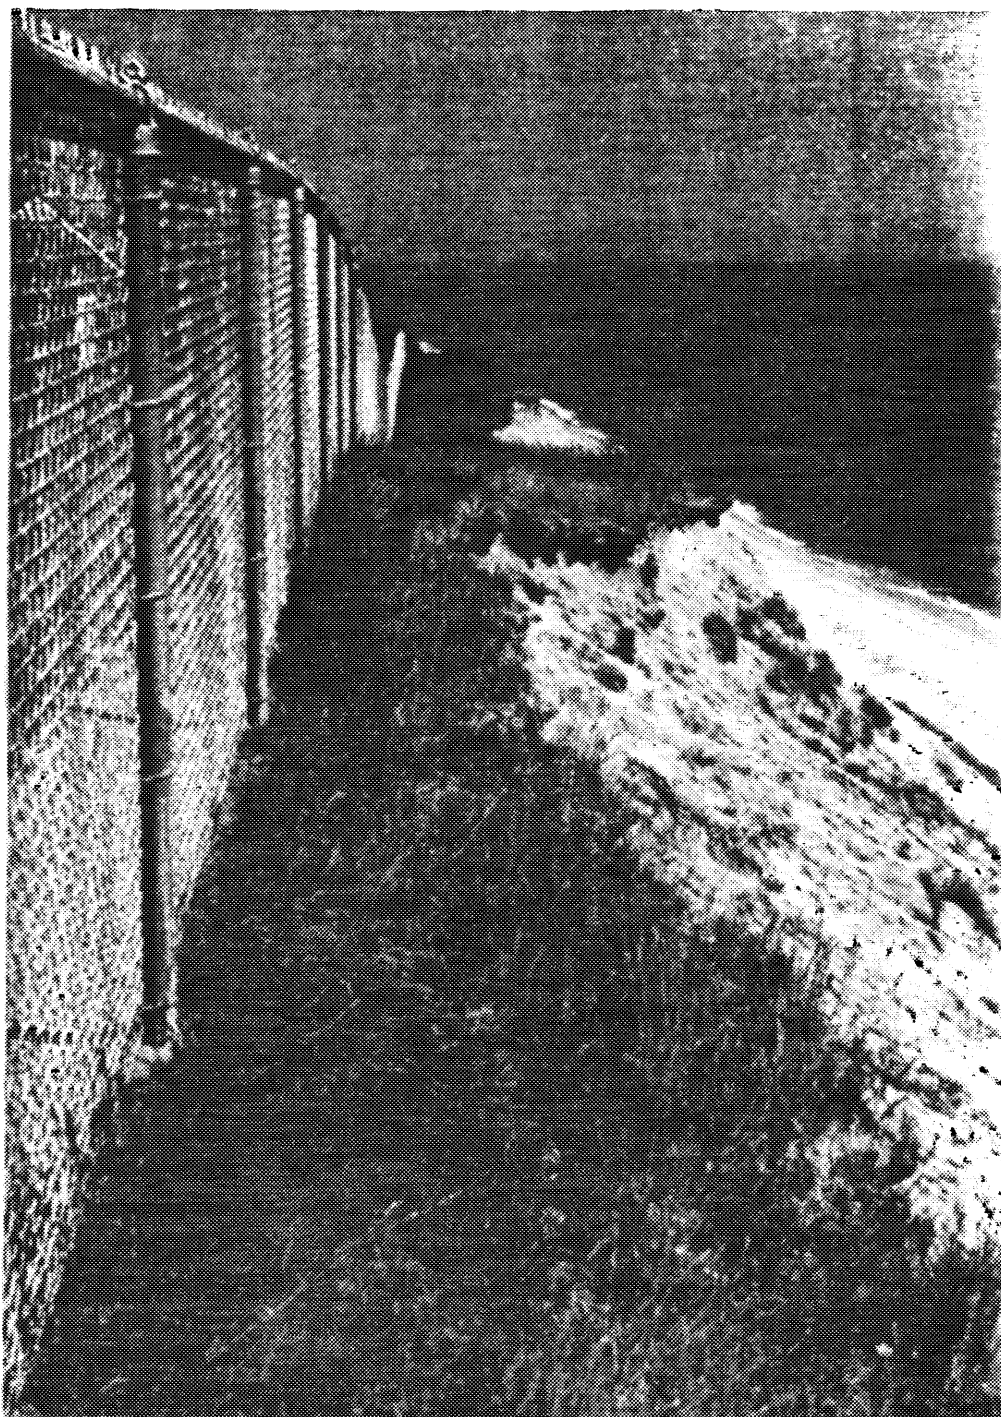
PHOTO 11 - CLOSE PROXIMITY OF BLUFF EDGE TO FENCE, JUNE 1989
(LOOKING NORTH IN FRONT OF LIGHTHOUSE)

The entire bluff edge is in an active state of erosion, but the residence structure is presently in the most danger due to its proximity to the edge.

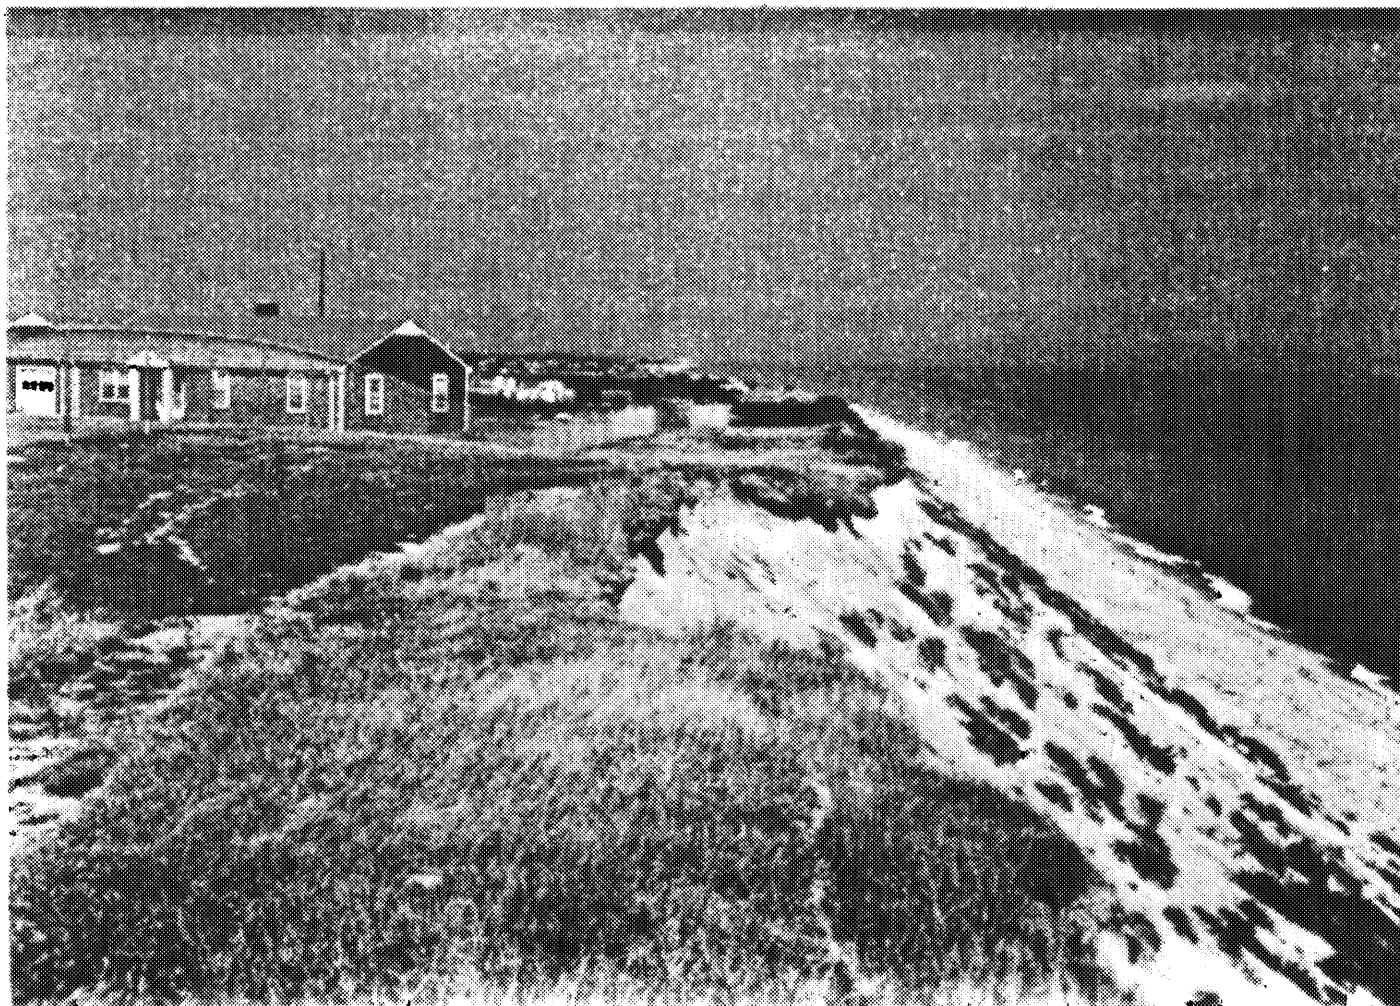
In summary, the top of the bluff in front of the lighthouse is eroding at an average rate of 8.0 feet per year over the last two years, 1987-1989. Photos 12, 13 & 14 show the dramatic recession of the bluff edge between September of 1985, and February and June of 1989. This situation will most likely persist until offshore bathymetry conditions change which may offer some form of natural protection to the base of the bluff, and the slope of the bluff stabilizes.

PHOTO 12 - TOP EDGE OF BLUFF, SEPTEMBER 1985

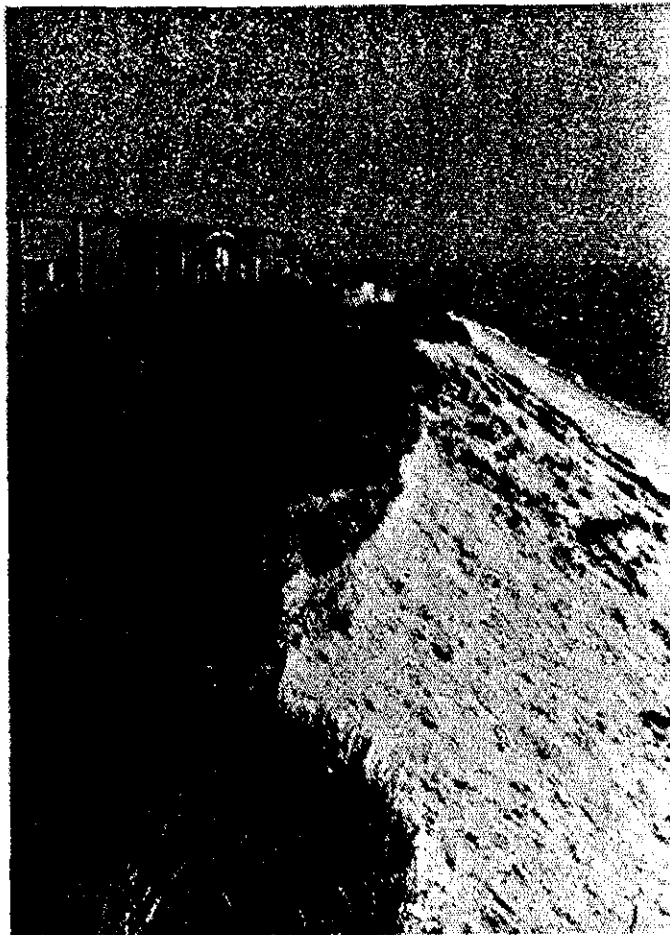
PHOTO 14 - TOP EDGE OF BLUFF, JUNE 1989
